STA-DRY® QCS2®

Winterizing Your Electrical Harness

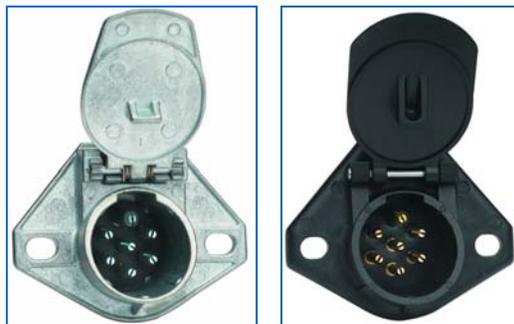
- Inner cavity sealed to prevent contaminants from passing to the wire harness
- Non-corrosive housing – resistant to magnesium chloride, salt, oil, grease and fuels
- Molded housing includes integrated flange to seal out moisture and corrosion
- Significantly reduces socket replacement time, lowering maintenance

It is essential to use a socket that is made to withstand the effects of moisture and corrosion. Today, fleets have more than one option available to them. Metal sockets are one option. They are cost effective and get the job done. However, the anti-corrosive property zinc will only succeed at helping to maintain the integrity of the actual socket housing itself, rather than the electricals within. This is because all metal sockets leak. Due to their construction, they are not a completely sealed component. So what does a fleet need to do? Start by converting metal sockets to glass filled nylon and make sure they are insert molded. Insert molding seals the pins to the housing which will prevent contamination from entering the harness system. This is your best bet at sealing out corrosion where it is most likely to begin.
